Final
Cultural Landscape Report
Volume 1

Pahaquarry Copper Mine
DELAWARE WATER GAP

August 1995

by
Steve R. Burns Chavez
A. Berle Clemensen

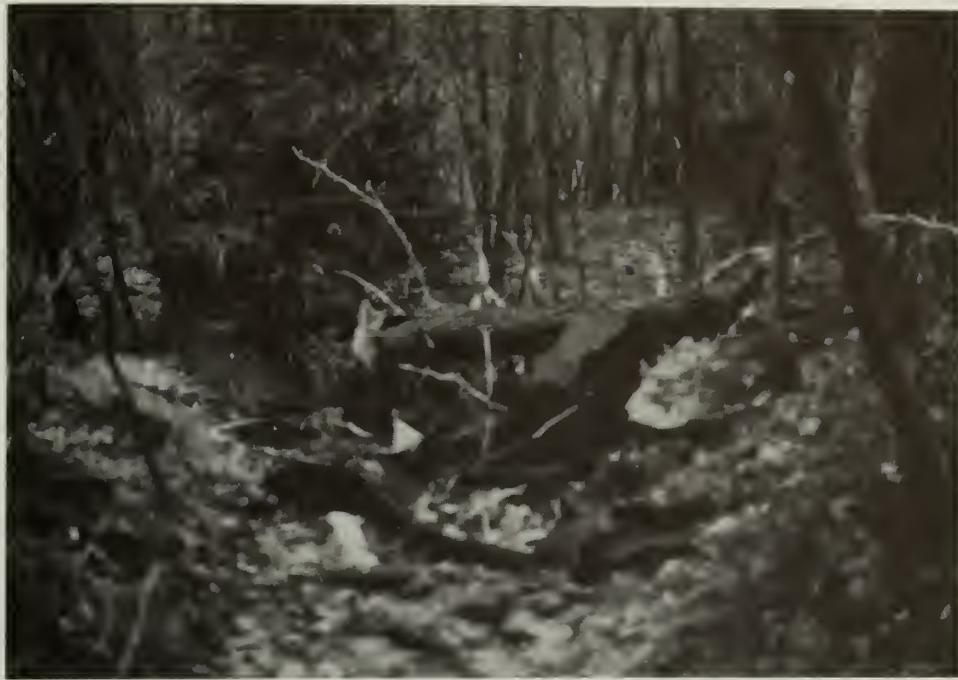
Figure 6C Photo 30
Unknown probably begun in 1862 and reworked in 1901-1912 period test trench

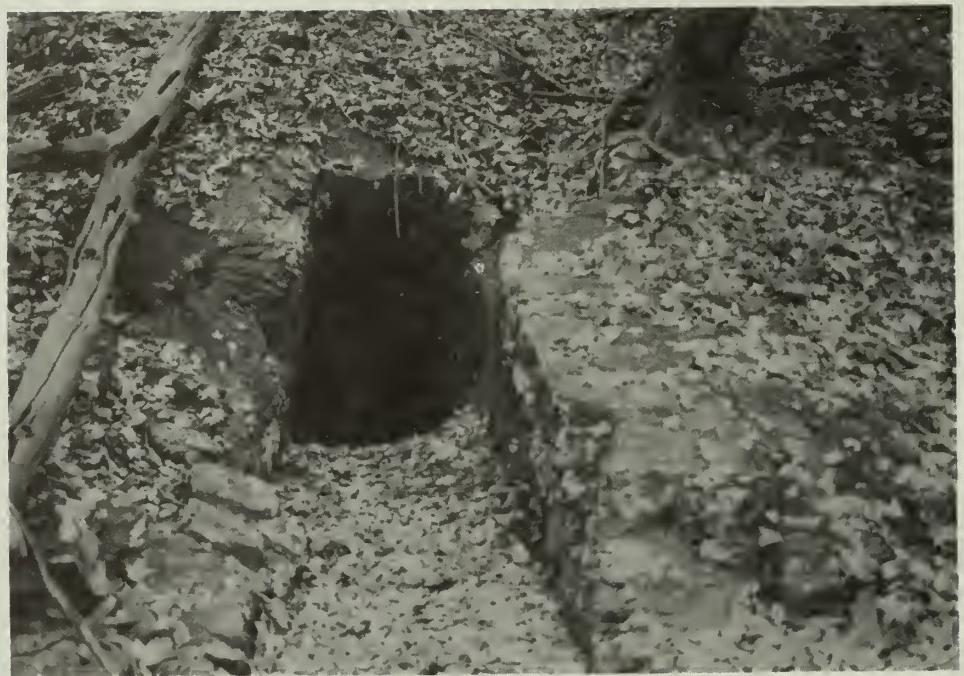
Figure 6C Photo32
1900s era tunnel on upper river terrace west of Minebrook

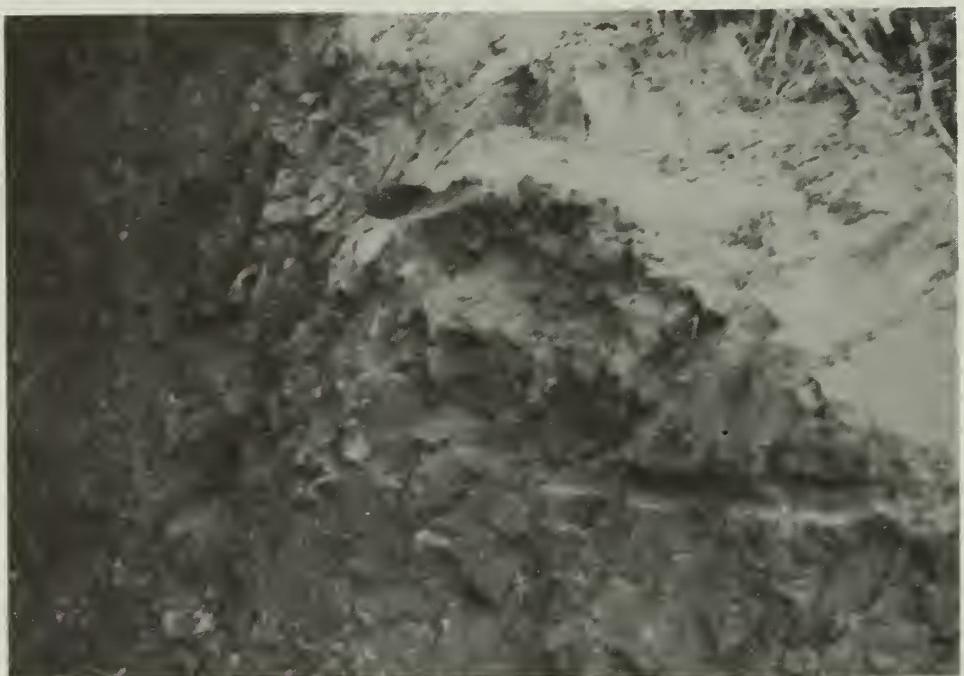
Figure 6C Photo 33
1900s tunnel on upper river terrace showing drill marks

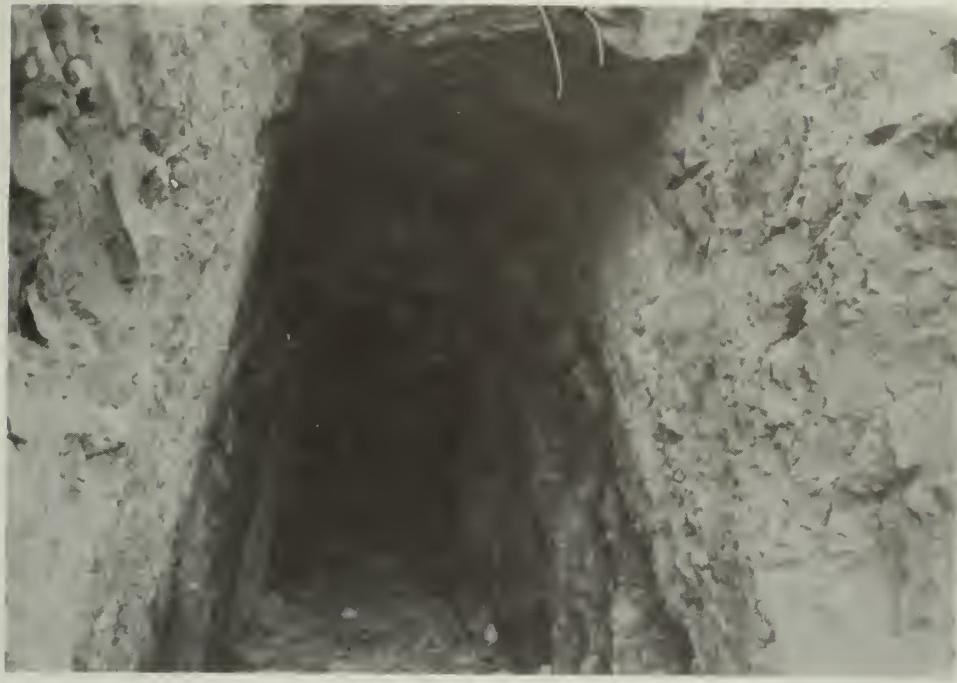
Figure 6C Photo 34
1900s era tunnel on upper river terrace showing interior

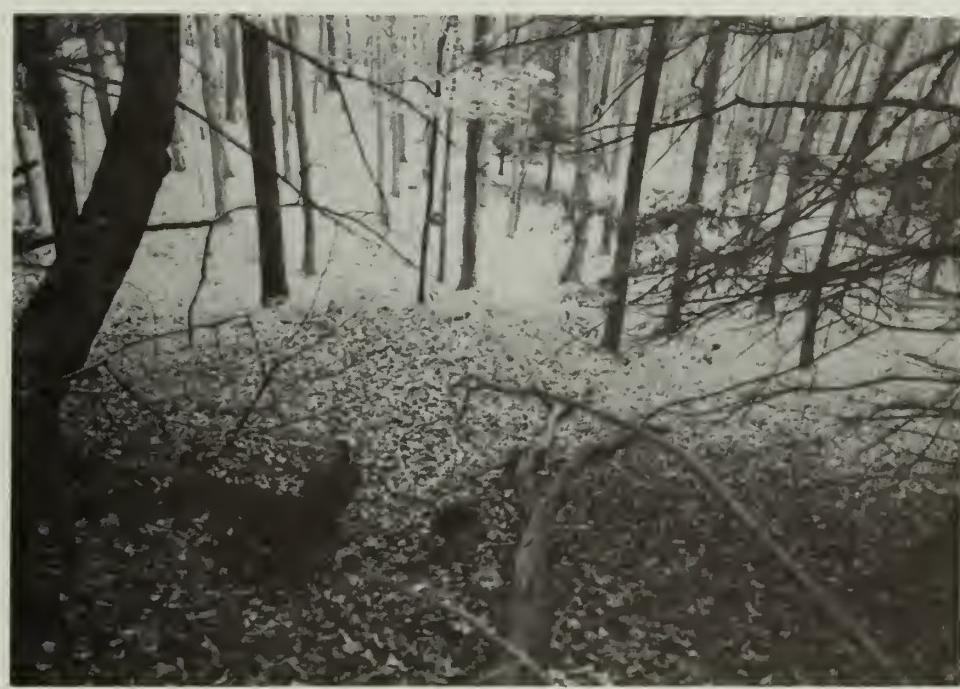
Figure 6C Photo 35
1900s era tunnel on upper river terrace from above looking at spoil pile

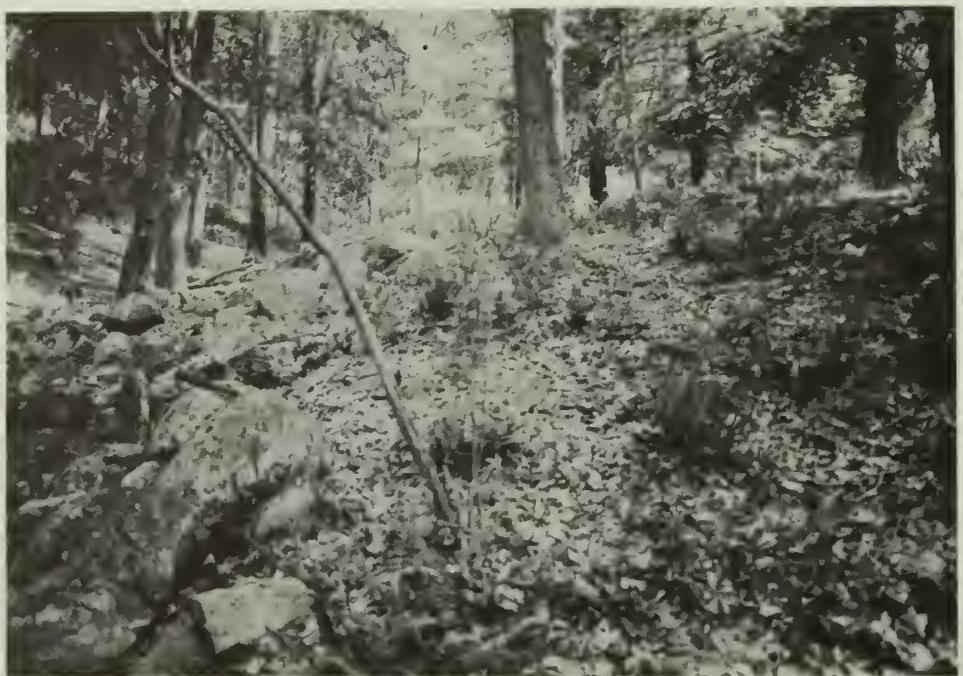
Figure 6D Photo 1
Possibly 1750s boulders apparently placed along ravine bank

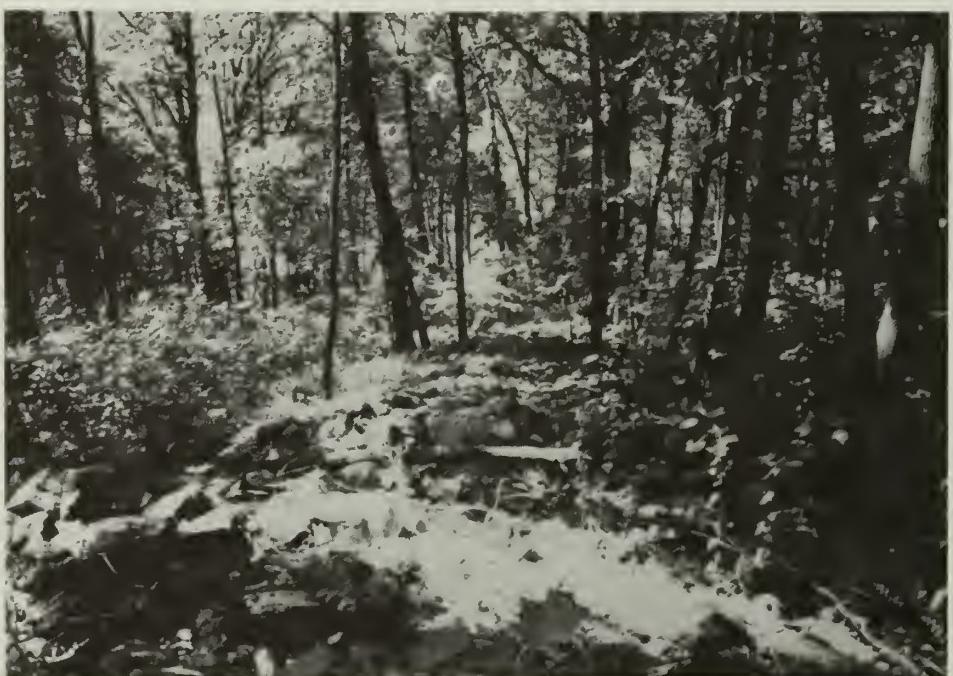
Figure 6D Photo 2
Probably early 1800s field stone rock wall

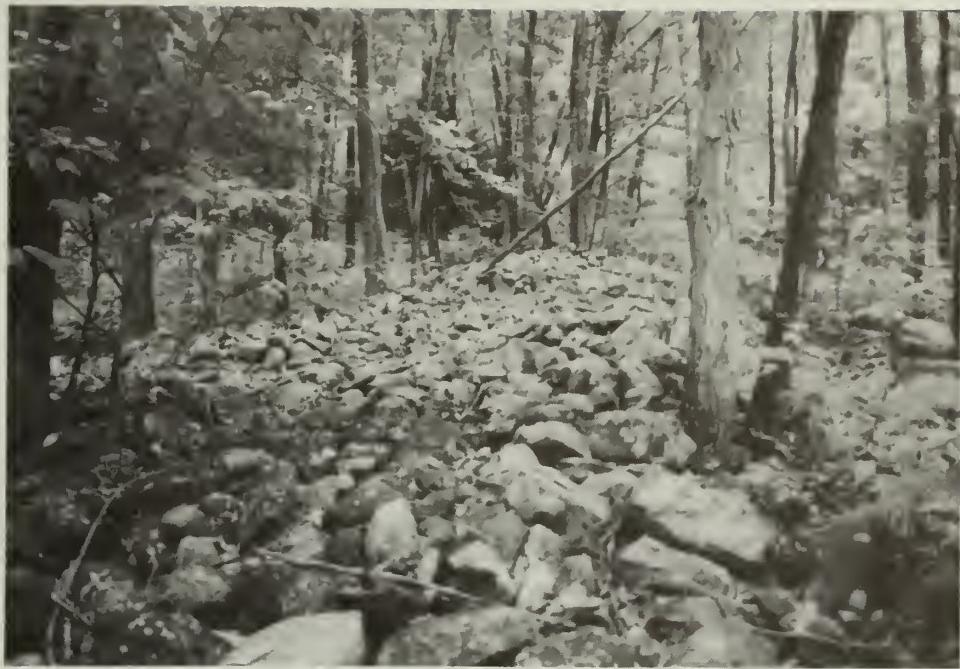
Figure 6D Photo 3
Probable early 1800s stone field wall

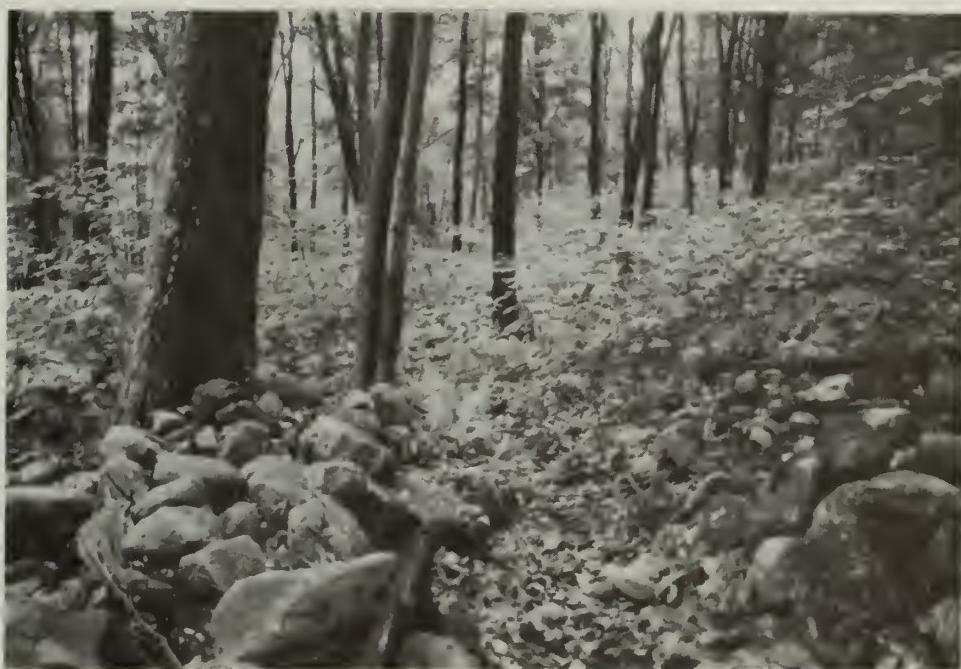
Figure 6D Photo 4
Probable early 1800s stone field wall with trail opening probably
made by Boy Scouts

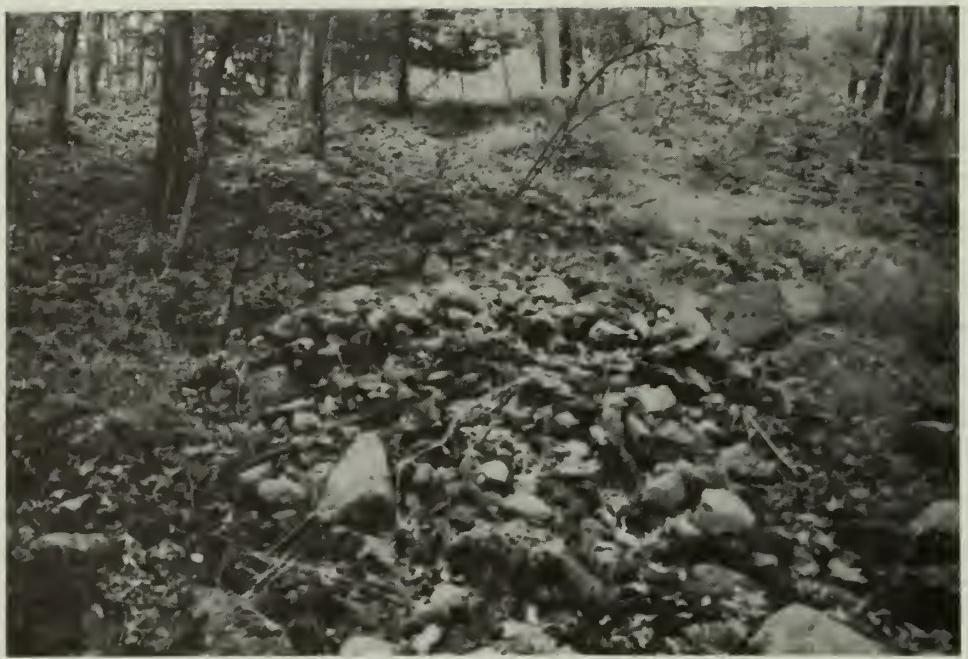
Figure 6D Photo 5
Probable early 1800s stone field wall

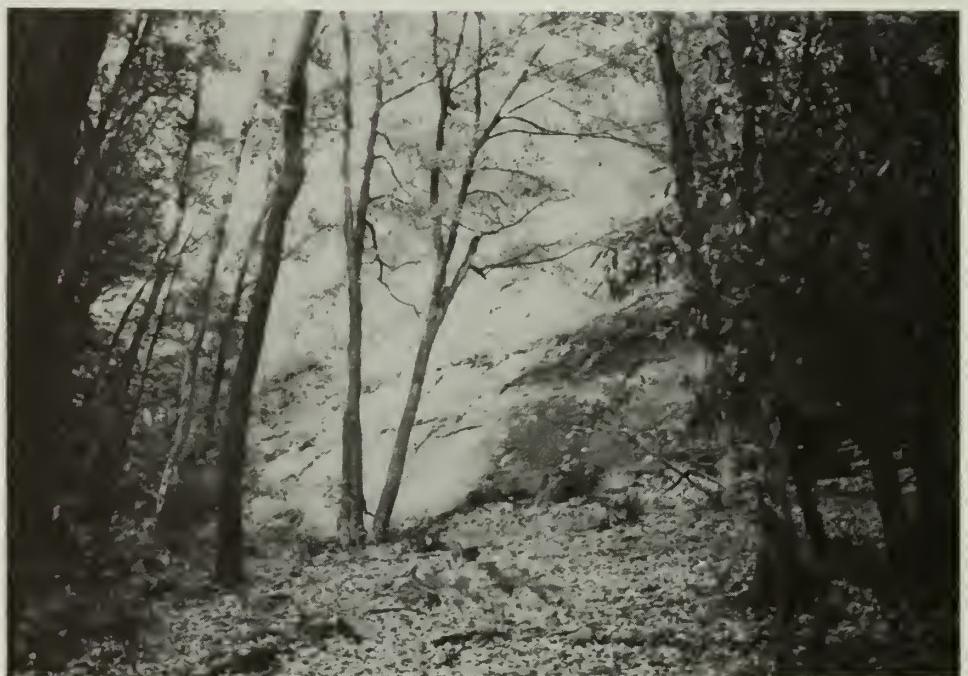
Figure 6D Photo 6
Rock face of outcrop thought to be focus of original 40 acre mine lot purchased in 1750s

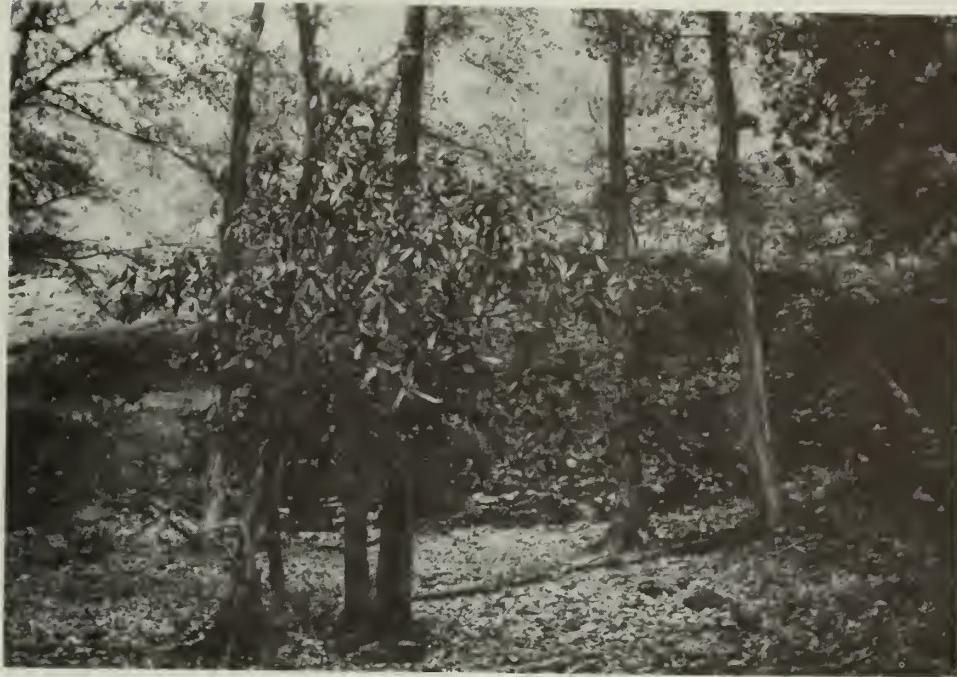
Figure 6D Photo 7
Rock face of outcrop thought to be focus of original 40 acre mine lot purchased in 1750s

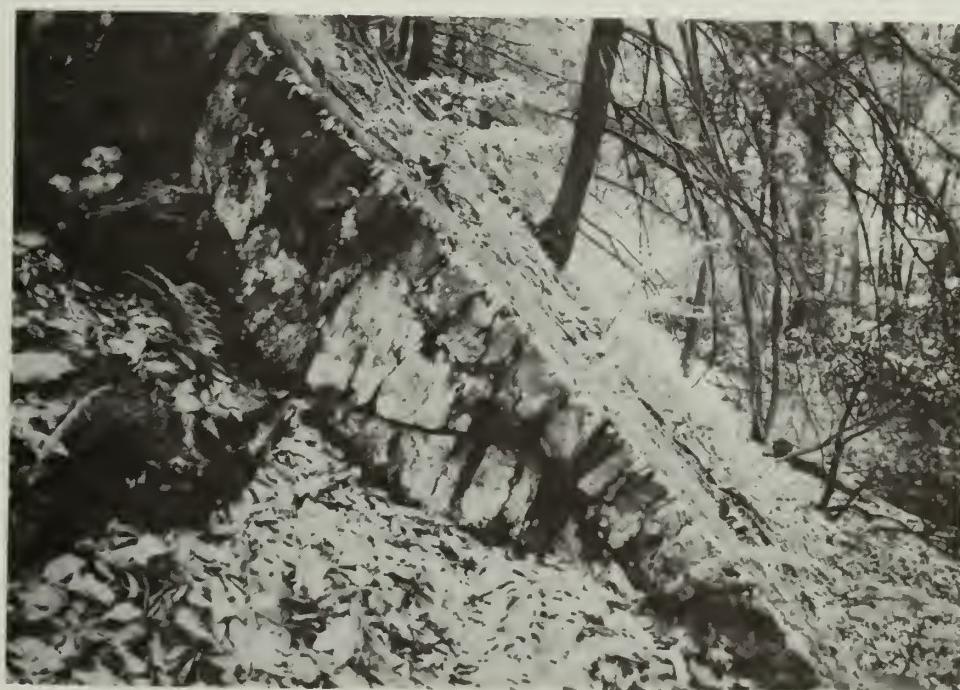
Figure 6D Photo 8
Close up of rock face on the south end of a possible 1750s exploratory mine area

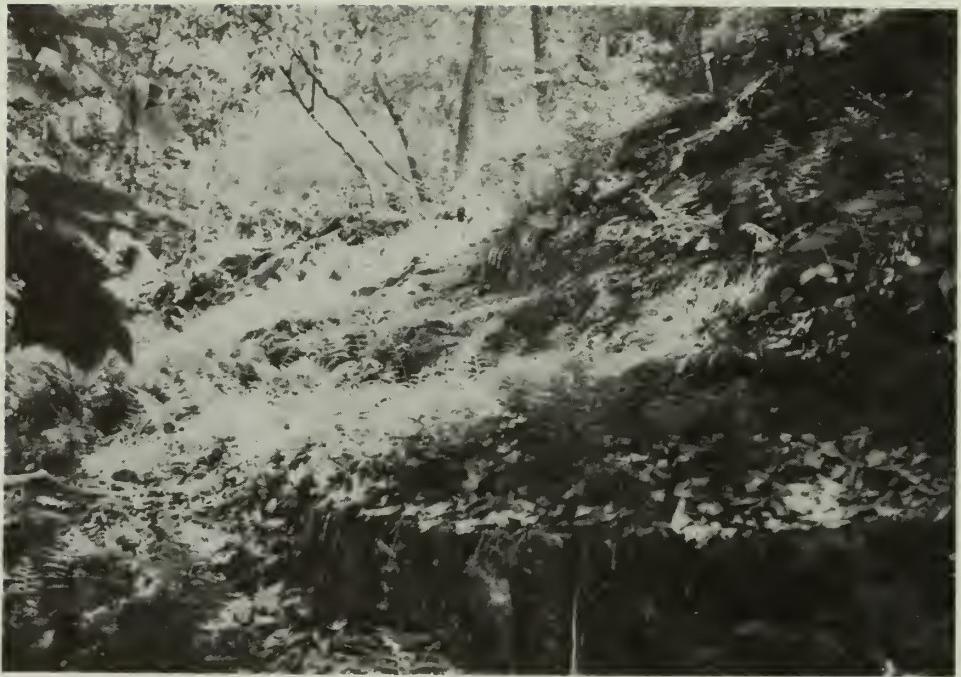
Figure 6D Photo 9
Area of rock face thought to be worked in 1750s

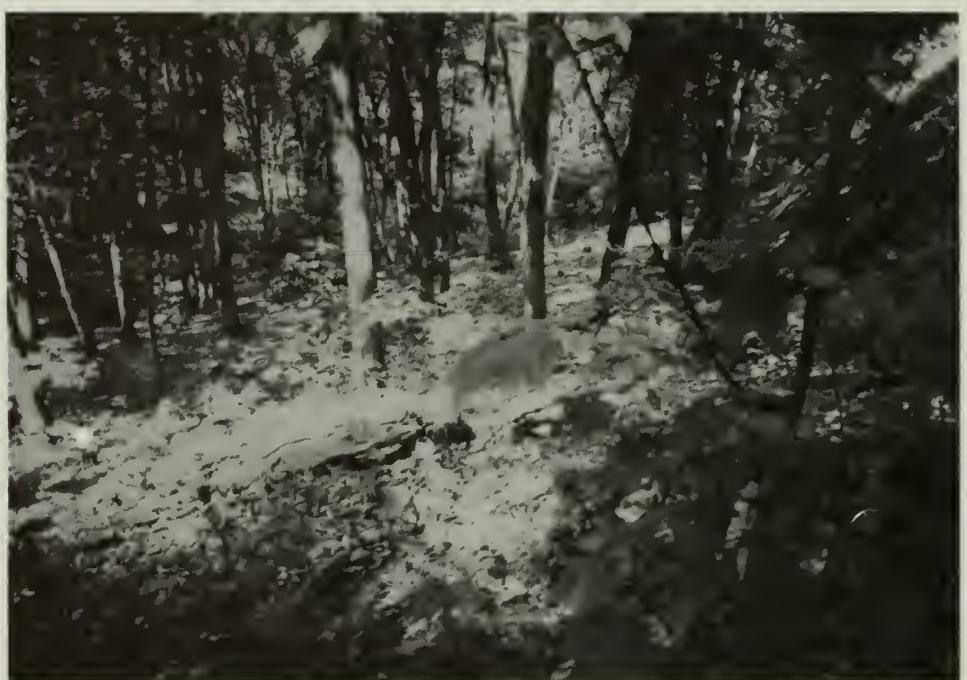
Figure 6D Photo 10
View of rock face and spoil below possible area worked in 1750s

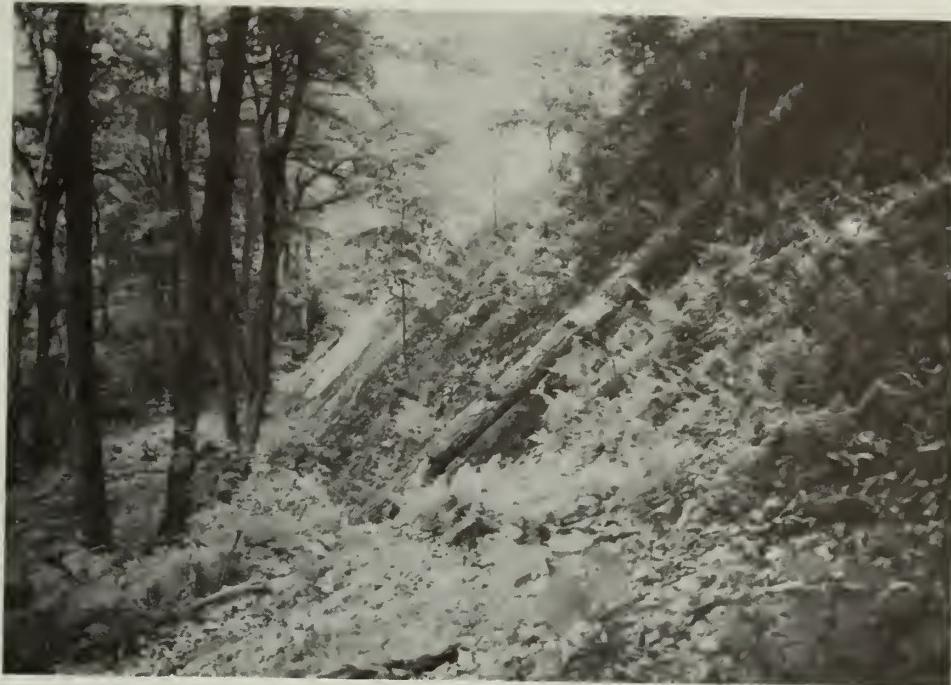
Figure 6D Photo 11
Looking east along rock face possibly worked in 1750s

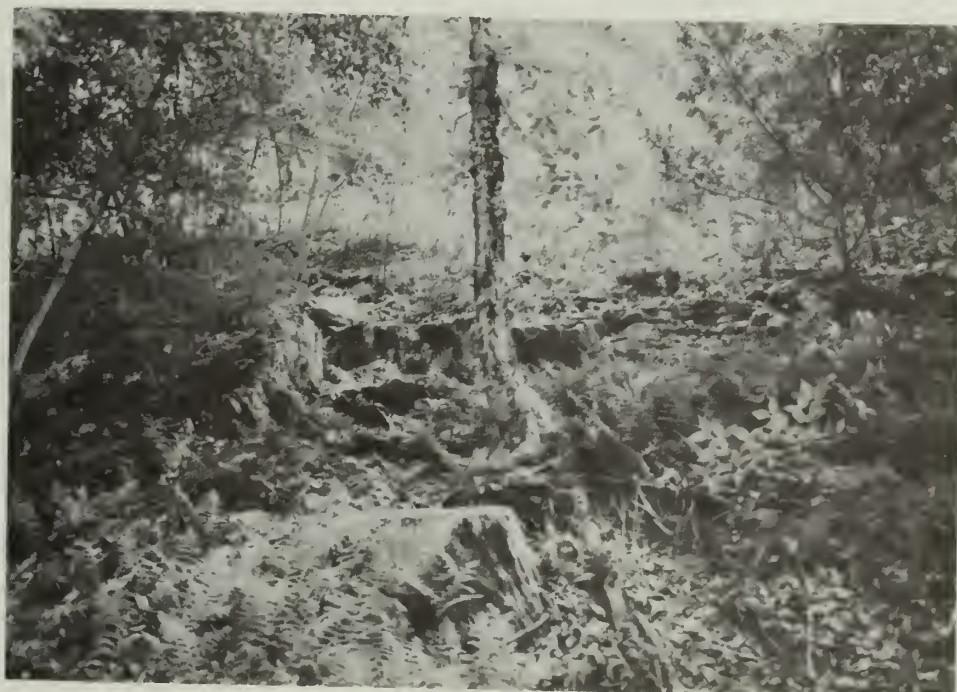
Figure 6D Photo 12
Looking up rock face on east end of rock face thought to be worked in 1750s

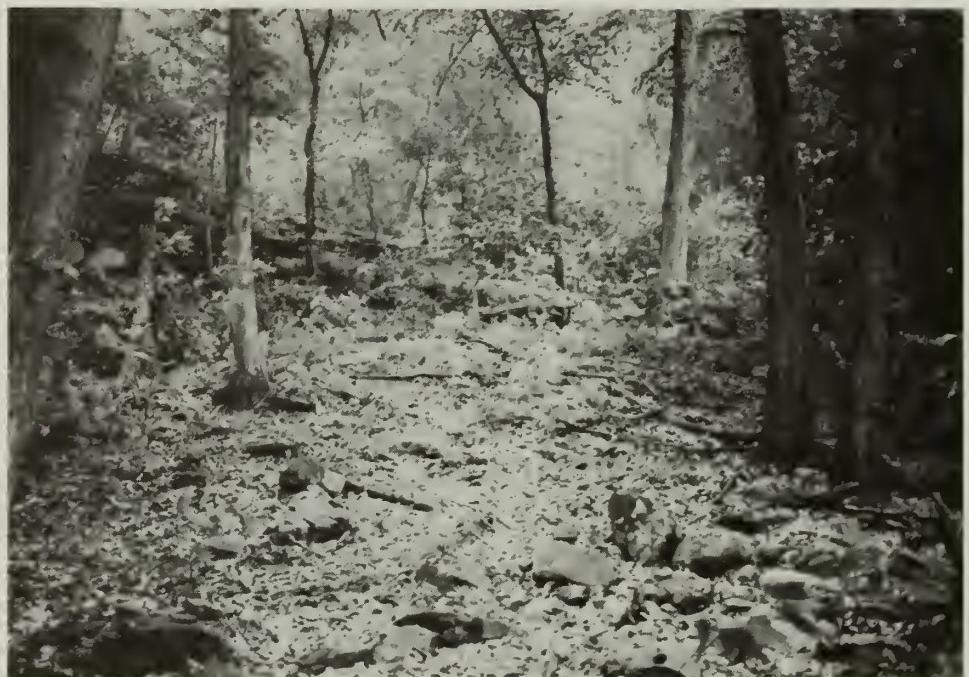
Figure 6D Photo 14
View of "spoil" from area possibly worked in 1750s

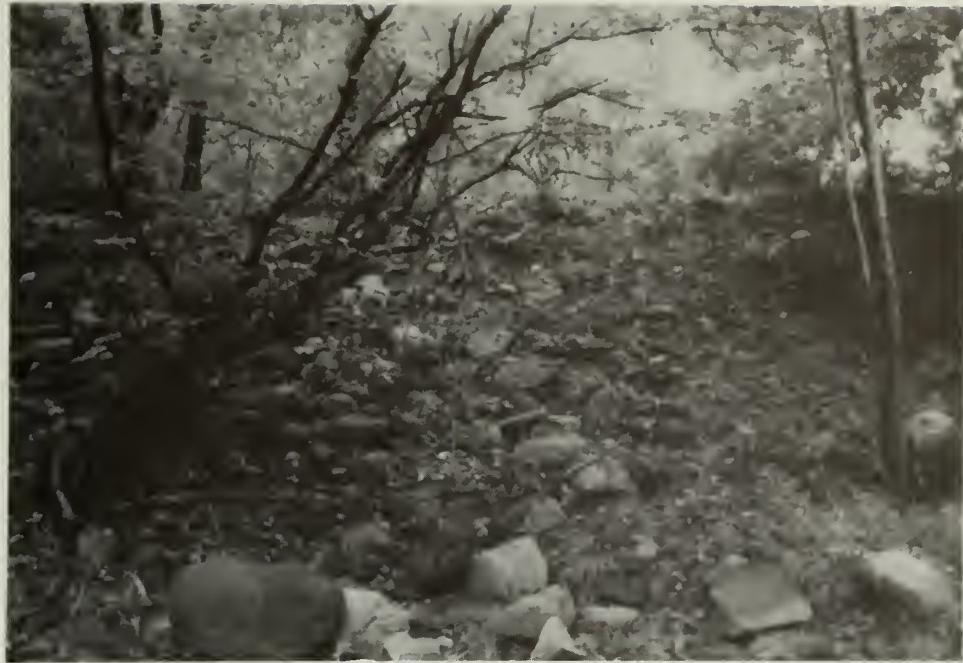
Figure 6D Photo 15
Collapsed section of post 1830 "Old Mine Road"

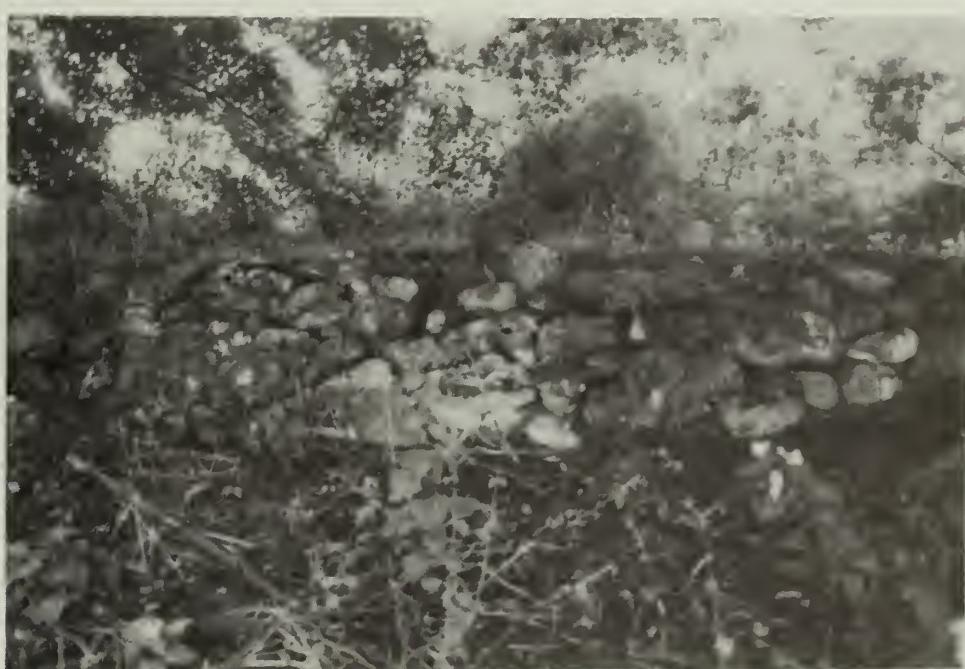
Figure 6D Photo 16
Post 1830 "Old Mine Road" wall

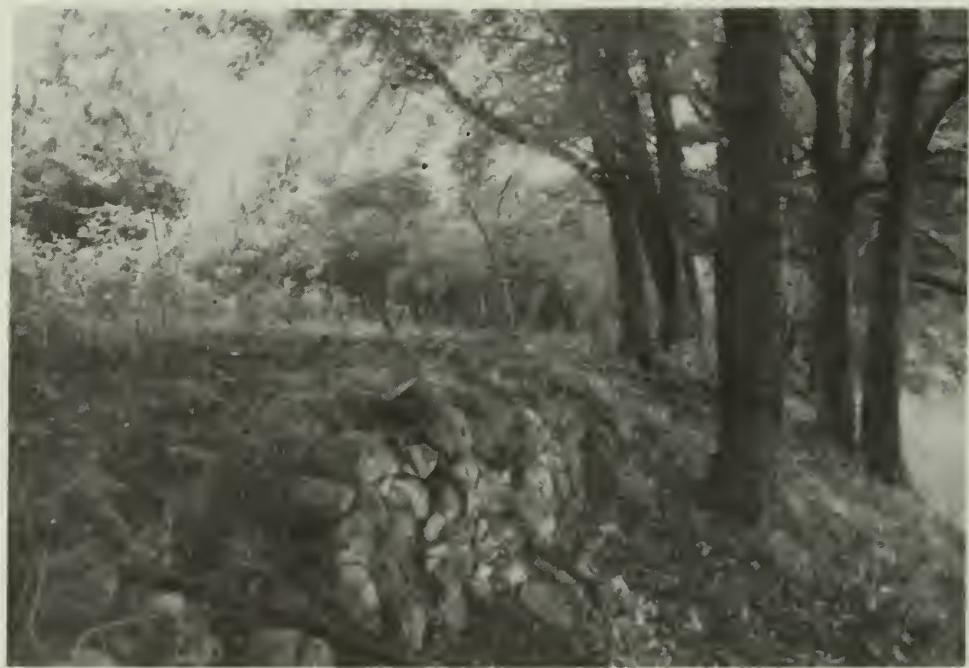
Figure 6D Photo 17
Post 1830 "Old Mine Road" wall

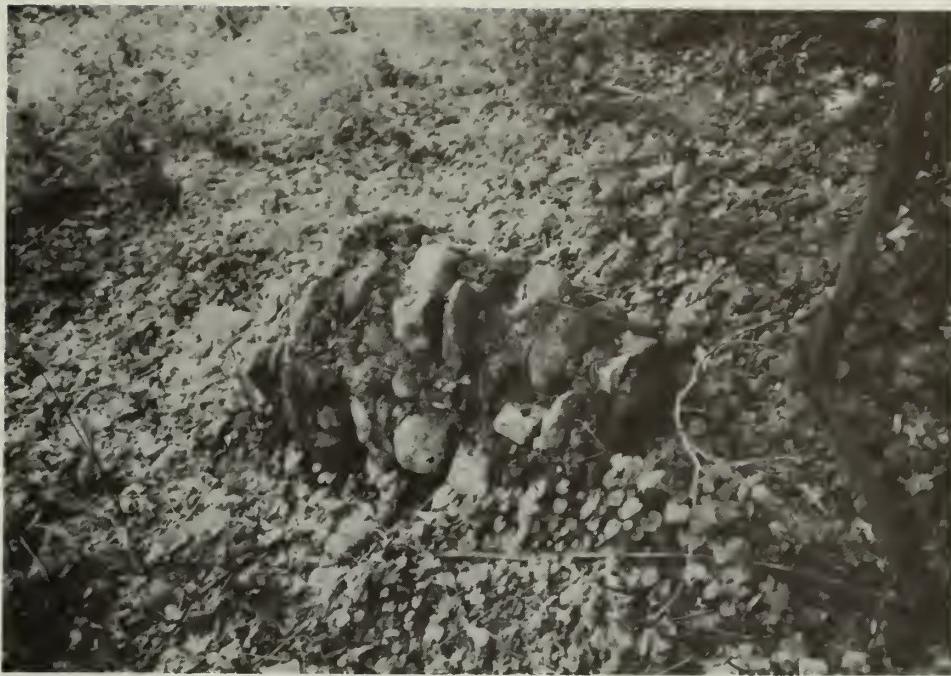
Figure 6E Photo 1
Boy Scout period drinking fountain in former parade field area

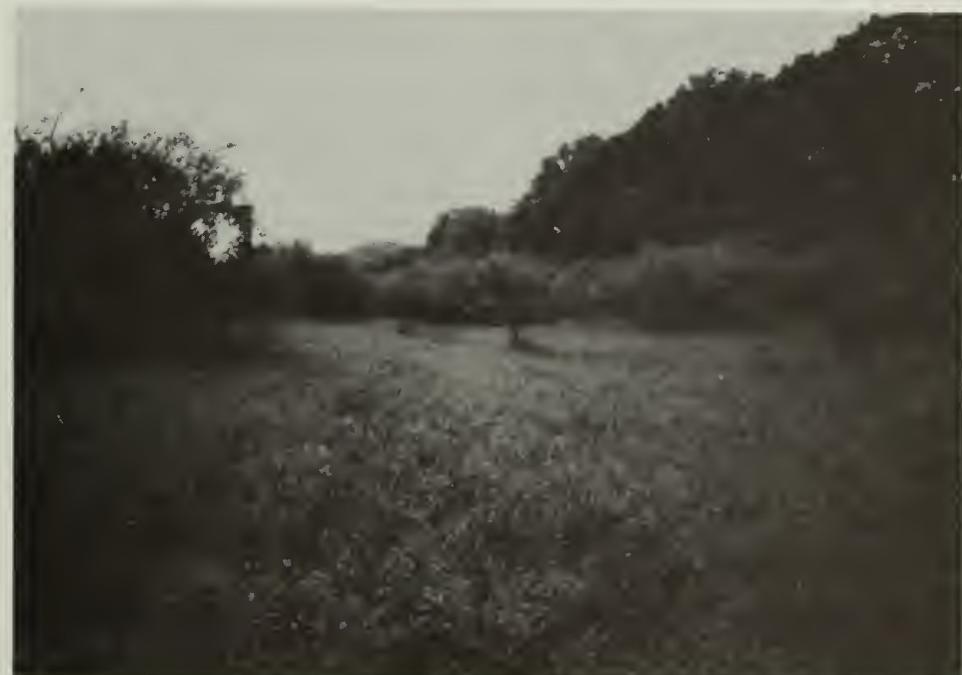
Figure 6E Photo 2
Boy Scout period field near archery area

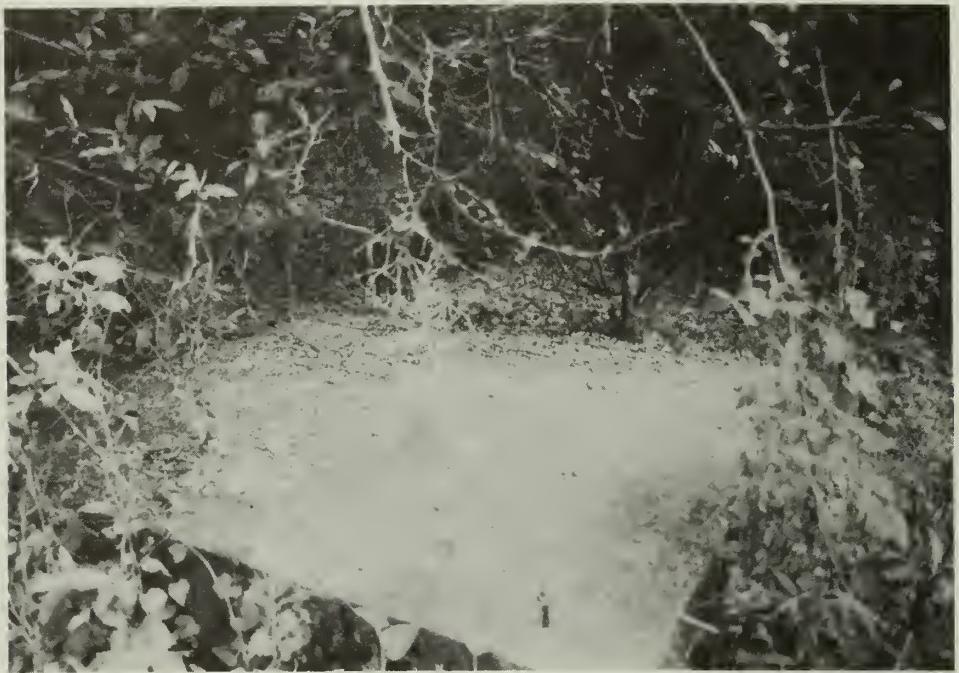
Figure 6E Photo 3
Boy Scout period archery site platform

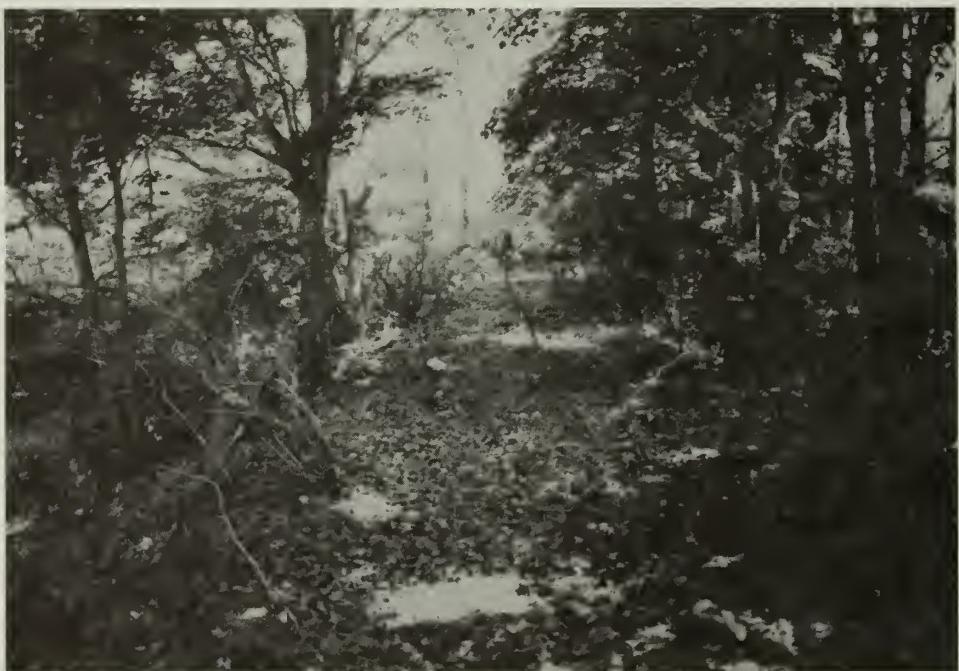
Figure 6E Photo 4
Boy Scout period road to hotel (Dingmans Ferry) looking towards old mine road

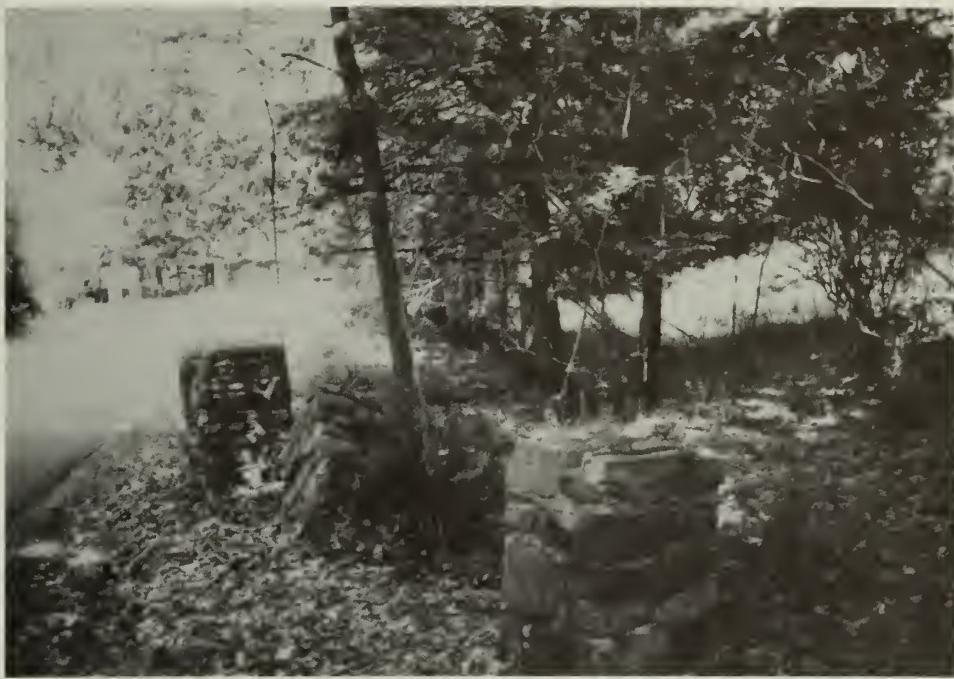
Figure 6E Photo 5
Boy Scout period entry pillars to camp

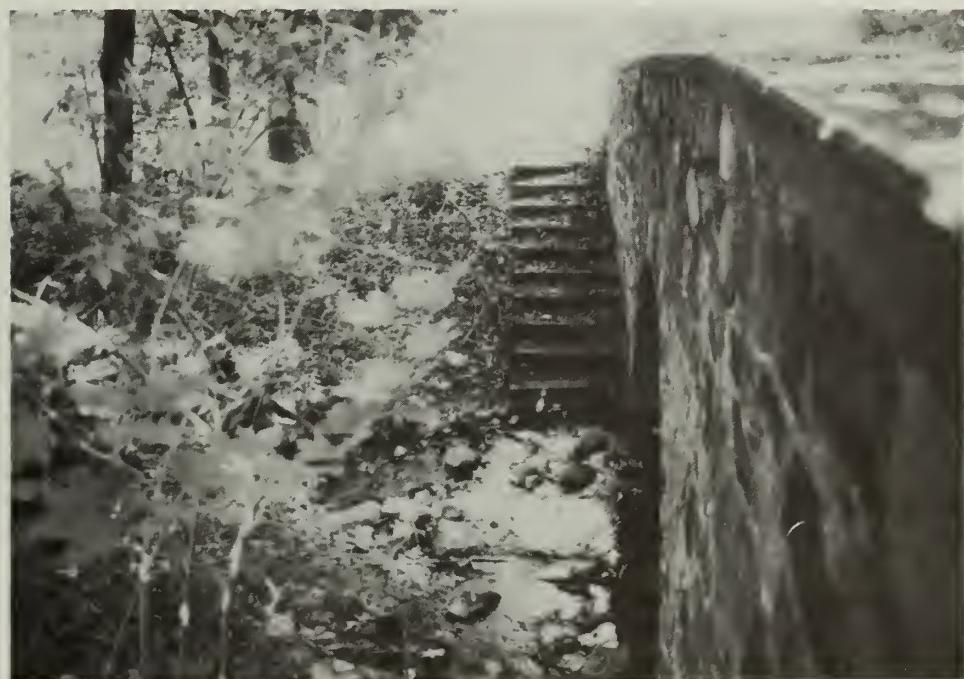
Figure 6E Photo 6
Boy Scout period steps added to Minebrook bridge

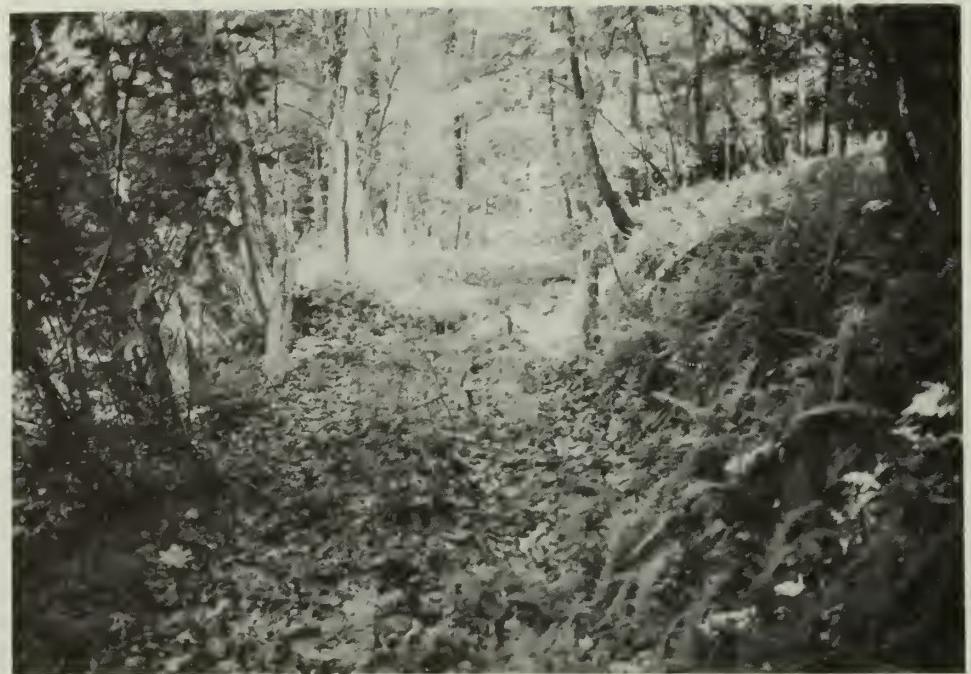
Figure 6E Photo 7
Boy Scout period road to tent cabin sites

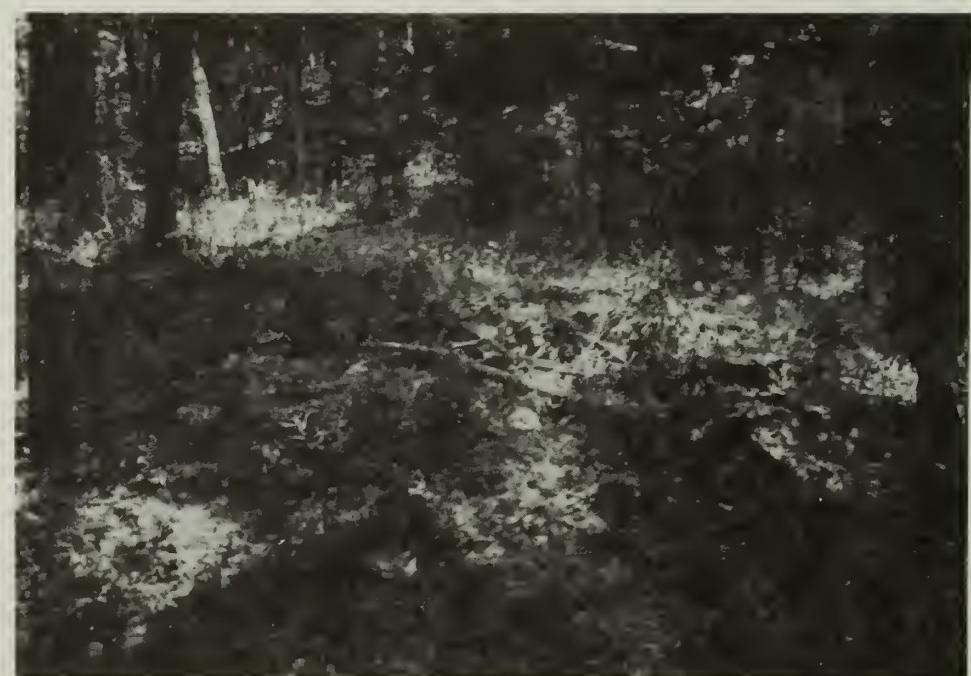
Figure 6E Photo 8
Boy Scout period ruins of Whinak camp site

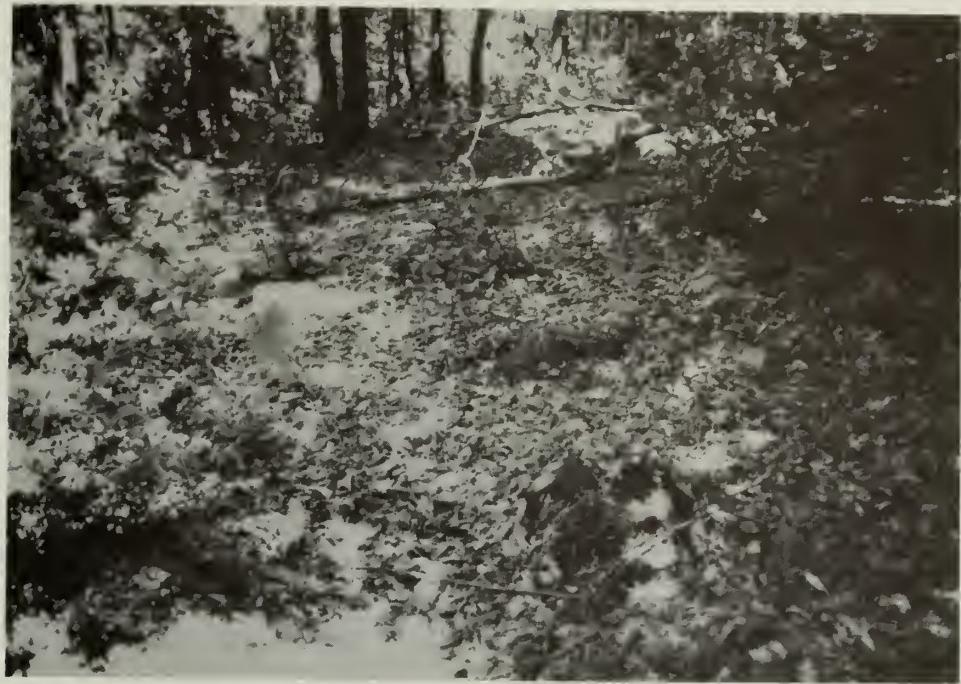
Figure 6E Photo 9
Boy Scout period ruins of Wipok camp site

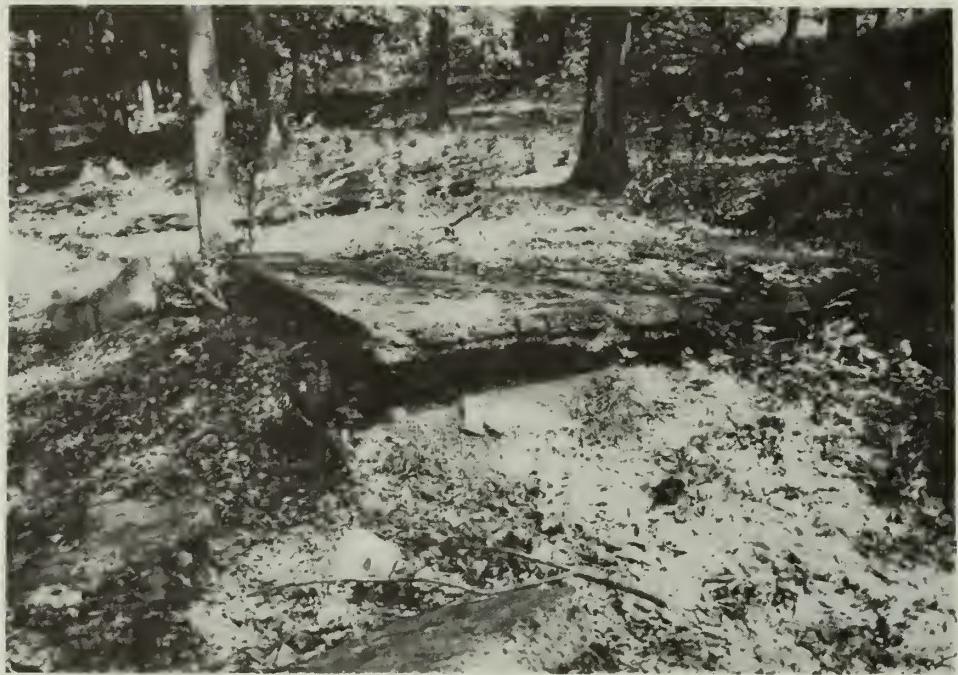
Figure 6E Photo 11
Boy Scout period ruins of slab

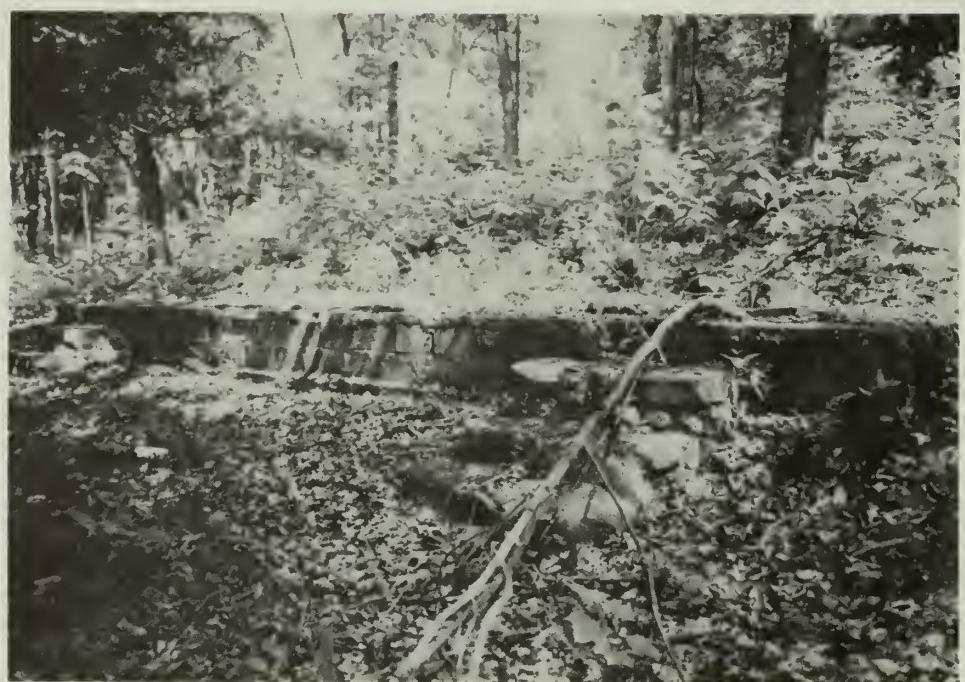
Figure 6E Photo 12
Boy Scout period ruins of latrine

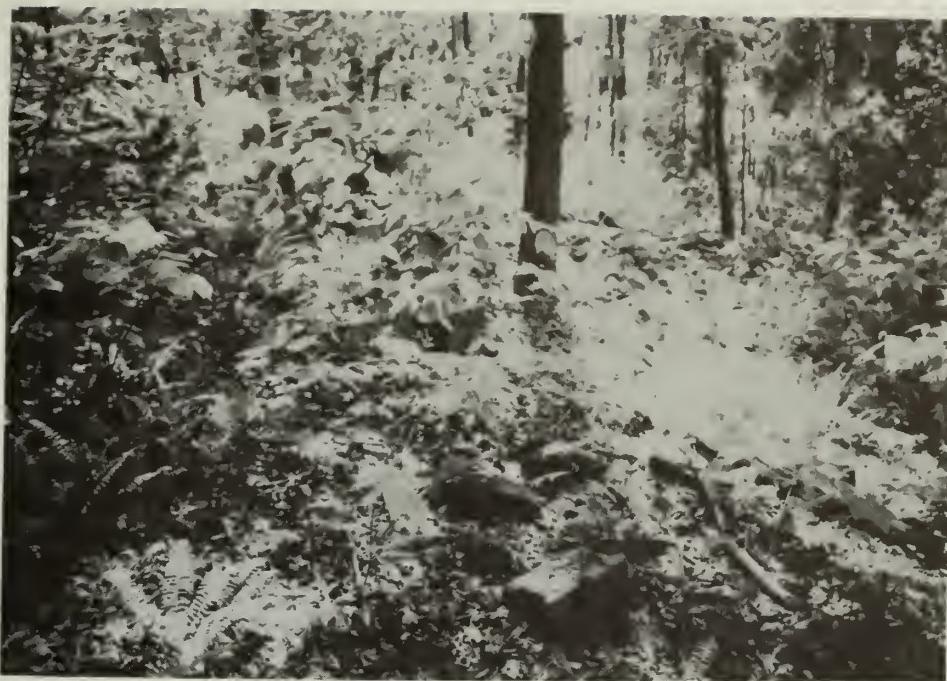
Figure 6E Photo 13
Boy Scout period ruins of latrine foundations

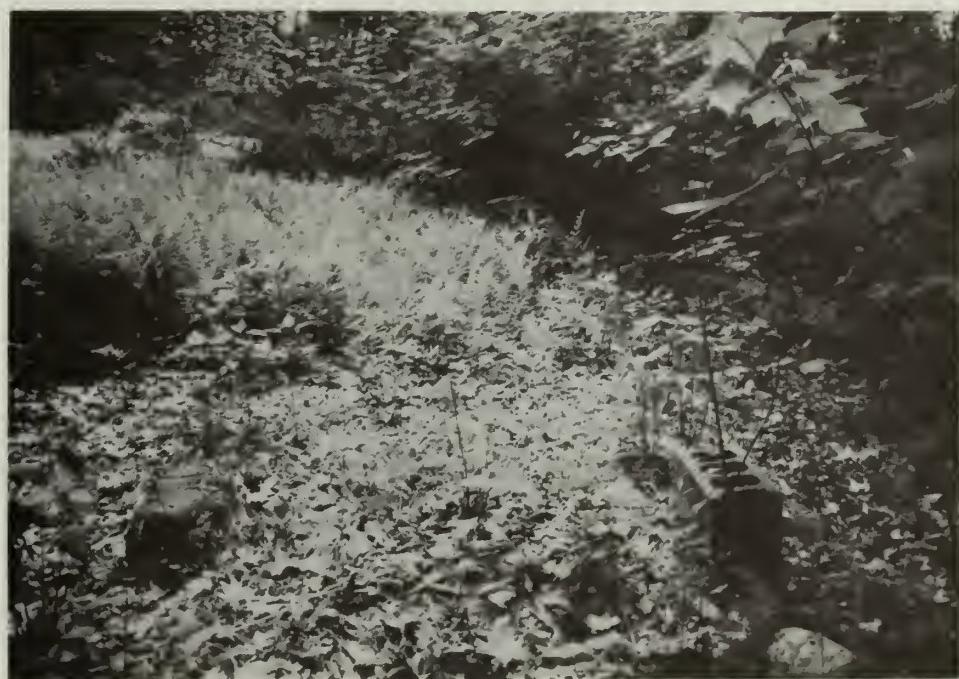
Figure 6E Photo 14
Boy Scout period ruins of rifle range
